THESIS FOR THE DEGREE OF DOCTOR OF PHILOSOPHY

Assessment of the lifetime of district heating pipes

Department of Industrial and Material Science
Chalmers University of Technology
Gothenburg, Sweden, 2020

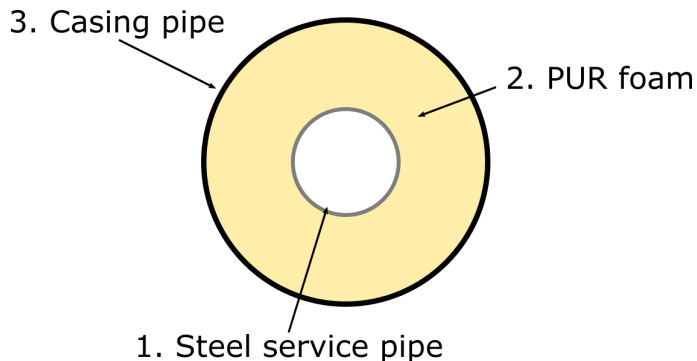
Figure 1.1: Sketch of DH pipes showing the three main components.

The third generation of DH pipes currently predominates and it is the focus of this work. The pipes consist of three bonded components: an external casing made of high-density polyethylene (HDPE), an intermediate insulating layer made of rigid polyurethane (PUR) foam, and an internal steel pipe, as shown in Figure 1.1. This type of DH pipe is called a pre-insulated pipe or a bonded pipe. Currently, the DH systems work at varying operating temperatures and these variations lead to axial movement of the steel pipe. The shear force generated between the PUR foam and the steel pipe can cause failure and in the worst scenario leakage in the joints between pipes. After many years of service, the mechanical and insulating properties of the pipes deteriorate.

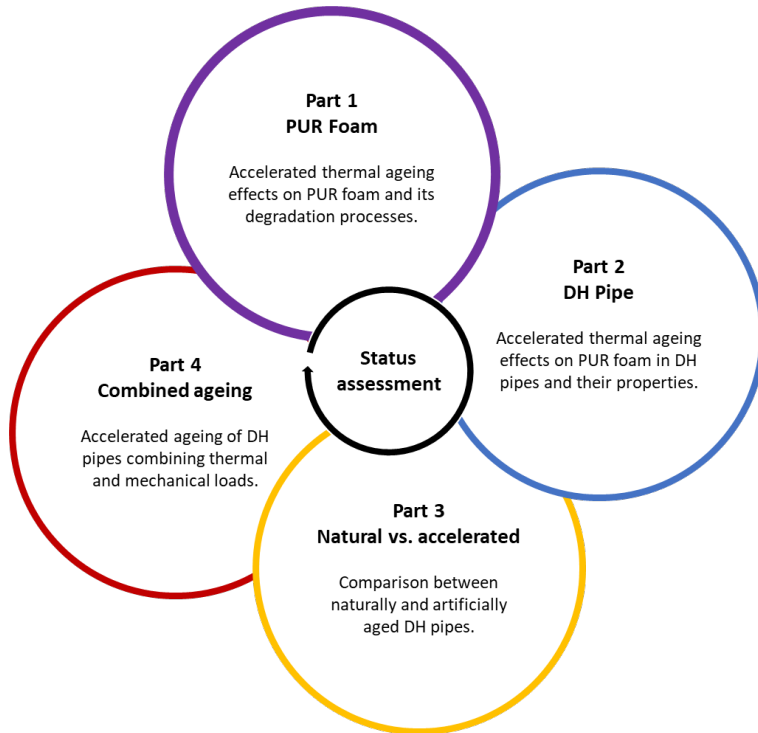
Figure 1.2: Structure of the project.

The project was divided into four parts. The degradation of the PUR foam from DH pipes was first studied to identify the most relevant processes activated by elevated temperature and different environments, viz., in the presence and absence of air. The results are summarised in Paper I. Second, the knowledge gained from the first part was applied to further studies of the ageing processes in DH pipes, where DH pipes were aged at different temperatures and their mechanical performance was studied during the ageing period. Changes in the chemical structure of PUR foam were shown using the FTIR technique by comparison with the results from the earlier work. Paper II summarises these results. Third, the effects of natural ageing in DH pipes were compared with those resulting from accelerated ageing in the laboratory. DH pipes from different locations were collected and brought to the laboratory for testing of the adhesion strength and for analysis of the chemical structure of the PUR foam. The results are summarised in Paper III. Finally, an experiment was designed to apply both thermal ageing and cyclic mechanical loads to DH pipes, so that the pipes were exposed to realistic operating conditions. The methodology and results are presented in Paper IV. Figure 1.2 summarises the structure of the project.

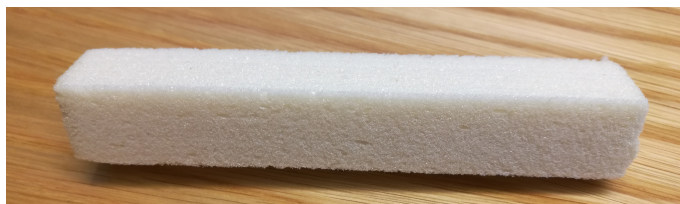
Figure 3.1: Rectangular PUR foam sample with dimensions 114 x 19 x 18 mm.

For this experiment, rectangular samples were cut from ordinary PUR foam (called o-PUR) obtained directly from DH pipes and from the ideal PUR block (called i-PUR), as shown in Figure 3.1. The samples were placed in ovens at $150 \pm 2^\circ\text{C}$, in two different environments, air and nitrogen. The experimental design is shown in Table 3.1.

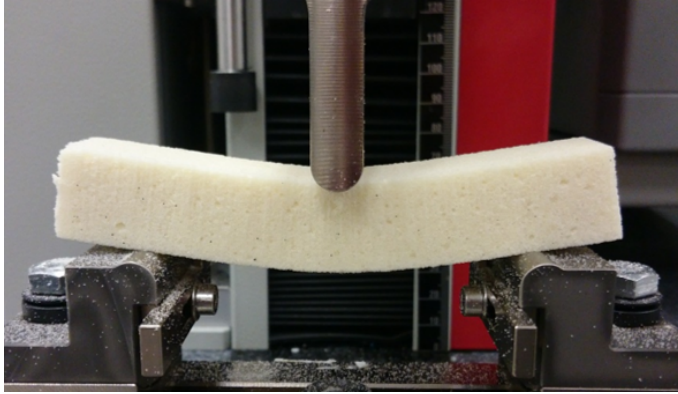
Figure 3.3: Three-point bending test on a PUR foam sample.

A three-point bending test was performed with a universal testing machine to evaluate the force at break and how it was affected by the accelerated ageing, as shown in Figure 3.3. The chemical structure was analysed using FTIR, and the gas composition by gas chromatography with tandem mass

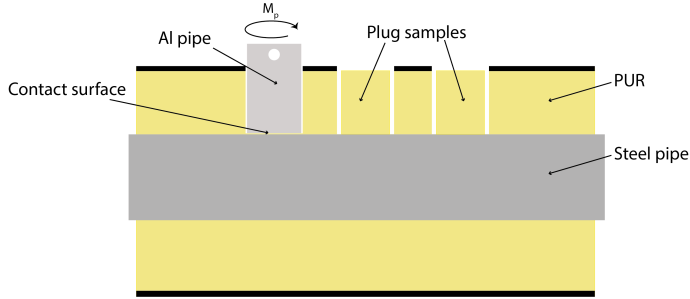
Figure 3.6: Sketch of the RISE plug method.

Adhesion between the PUR foam and the steel service pipe is essential for the good functioning of DH pipes. If this adhesion is lost, the DH pipes can fail. To study this property, a method developed at RISE and called the RISE plug method was used. This method was first described by Sällström [18] and developed further in this project. The adhesion strength is determined with a cylindrical test sample still adhering to the service pipe, the torque required to remove the PUR cylinder from the steel service pipe being measured with a torque transducer, as shown in Figure 3.6. Full details about the test procedure are given in Paper II.

An electrical torque transducer was used to apply the torque with a constant angular velocity and to measure the maximum torque at break. This method was used to measure the adhesion strength of both artificially and naturally aged DH pipes and to obtain as much data as possible for comparison. The test rig was also modified so that measurements could be made directly on pipes that are still in service.

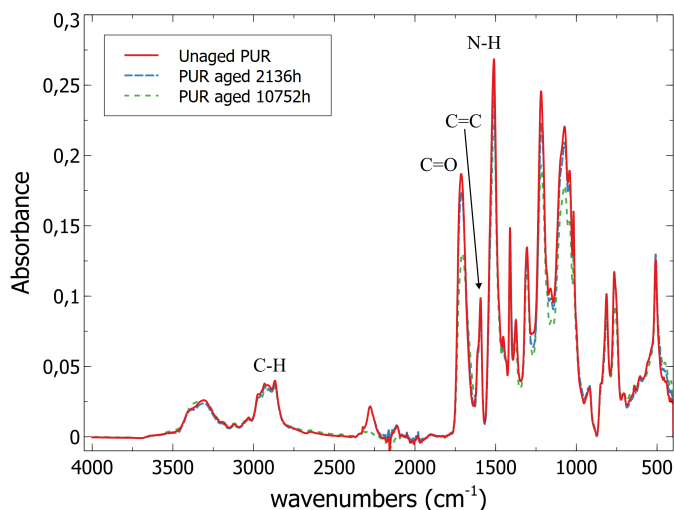
Figure 3.7: FTIR spectra of unaged and aged samples.

Figure 3.7 shows the spectra of unaged and aged PUR samples. To make the changes easier to assess, the relevant peaks were normalised with respect to the reference peak at 1595 cm^{-1} corresponding to the vibration of C=C bond in the aromatic rings, which are thermally stable, was chosen. Particular attention was paid to the peaks at 1712 cm^{-1} for the C=O bond and 1512 cm^{-1} for the N-H bond in the urethane linkage, to indicate degradation of the PUR foam. Indexes of absorbance were obtained and plotted as a function of ageing time. This methodology was used in Papers I–IV.

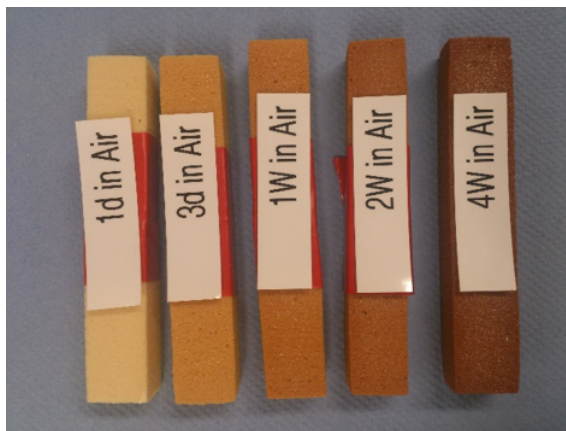
Figure 4.1: PUR samples aged at 150°C in air shows a progressive change in the colour with increasing ageing time.

Ageing in an inert nitrogen environment led to no remarkable change except for a small decrease in the weight of the samples, probably due to loss of volatile components that diffused out from the PUR foam. In contrast, changes in the dimensions and weight were observed in addition to the discolouration of PUR samples aged in air. In the case of the PUR samples marked o-PUR and i-PUR, the measurements of weight and dimensions showed some differences in behaviour between the o-PUR and i-PUR samples at the beginning of the ageing. The i-PUR was produced in a more controlled manner, which probably gave it a more homogeneous PUR morphology, mak-

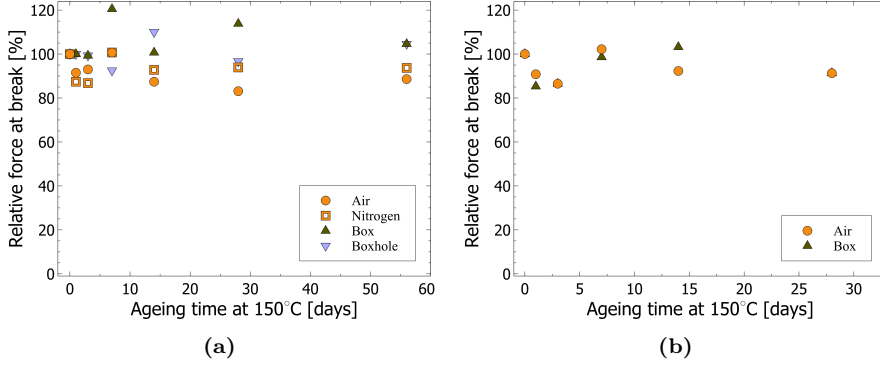
Figure 4.2: Relative force at break in a three-point bending test after different ageing times in different environments. (a) o-PUR foam and (b) i-PUR foam [Figure 8 in Paper I].

The force needed to break the samples in a three-point bending test after different ageing times is shown in Figure 4.2. Each point is the average of five measurements and the values are normalised with respect to a reference value measured on unaged samples. The breaking force did not decrease with increasing ageing time regardless of the ageing condition. This breaking force is a measure of the cohesion strength of the PUR foam and is not related to the strength of the adhesion between the PUR foam and the steel pipe. To clarify this difference, a single-point bending test was performed on triangular PUR samples still attached to the steel pipe aged at 150°C in a nitrogen environment, as described in Section 3.3.5. Figure 4.3 shows that the force measured in the single-point bending test decreased by 40% after approximately 20 days and remained at this level after 90 days, whereas the breaking force measured by the three-point bending test decreased by only about 7% and remained at the same level for almost 60 days.

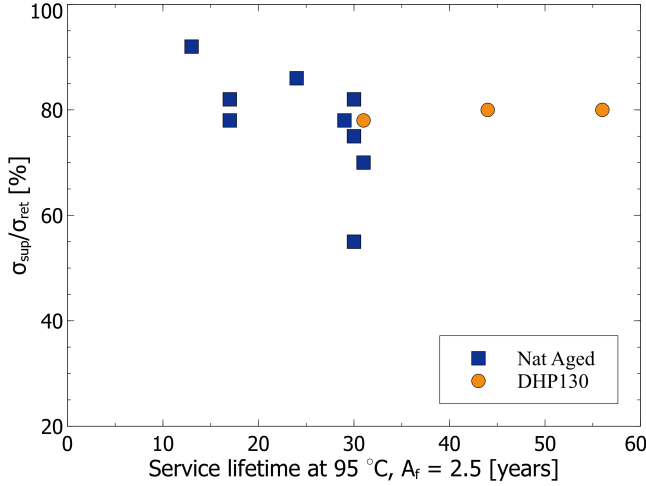
Figure 4.9: Adhesion strength ratio as a function of the calculated service time at 95°C using $A_f = 2.5$.

the calculated service times with $A_f = 2.5$. Most of the points are located between 70% and 90% and independent of the recalculated time. Only one measurement was outside this range. The PUR foam of this pipe could be damaged due to leakage, but we did not receive enough information to confirm this. Three points from DHP130 were also added to Figure 4.9 and showed that the results from the accelerated ageing at 130°C were consistent with the results from the naturally aged DH pipes.

According to this result, the strength of the adhesion between the PUR foam and the steel pipe in a DH pipe that is operated continuously at 95°C for 56 years will decrease to 80%. It is noteworthy that other external factors can damage or alter the functionality of the DH pipes and end its service time earlier.

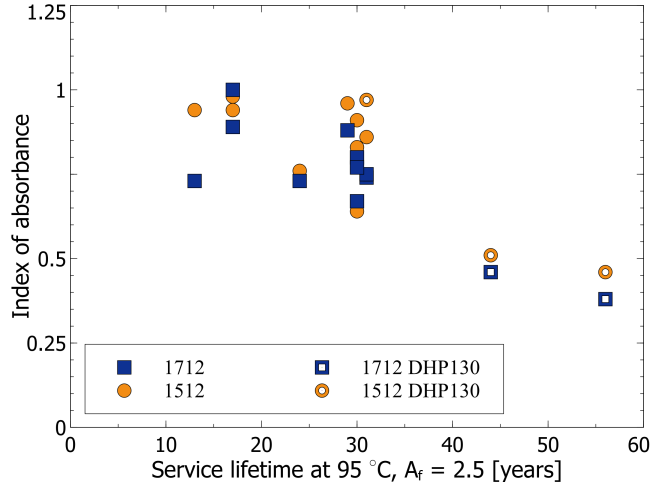
Figure 4.10: Index of absorbance from S pipes and three points from DHP130 for peaks at 1512 and 1712 cm^{-1} .

of the results. Figure 4.10 suggests what can happen if the DH pipes are operated at 95°C for 56 years.

Accelerated ageing at 130°C caused a further degradation of PUR foam as indicated by the decrease of the index of absorbance. Meanwhile, the adhesion strength remained unchanged, as shown previously in Figure 4.9. This finding suggests that the IR analysis could be useful to find indications of degradation in an early stage before the loss of the adhesion strength.
